SUMMARY REPORT

ACCIDENTAL NUCLEAR EXCURSION

RECUPLEX OPERATION

234-5 FACILITY

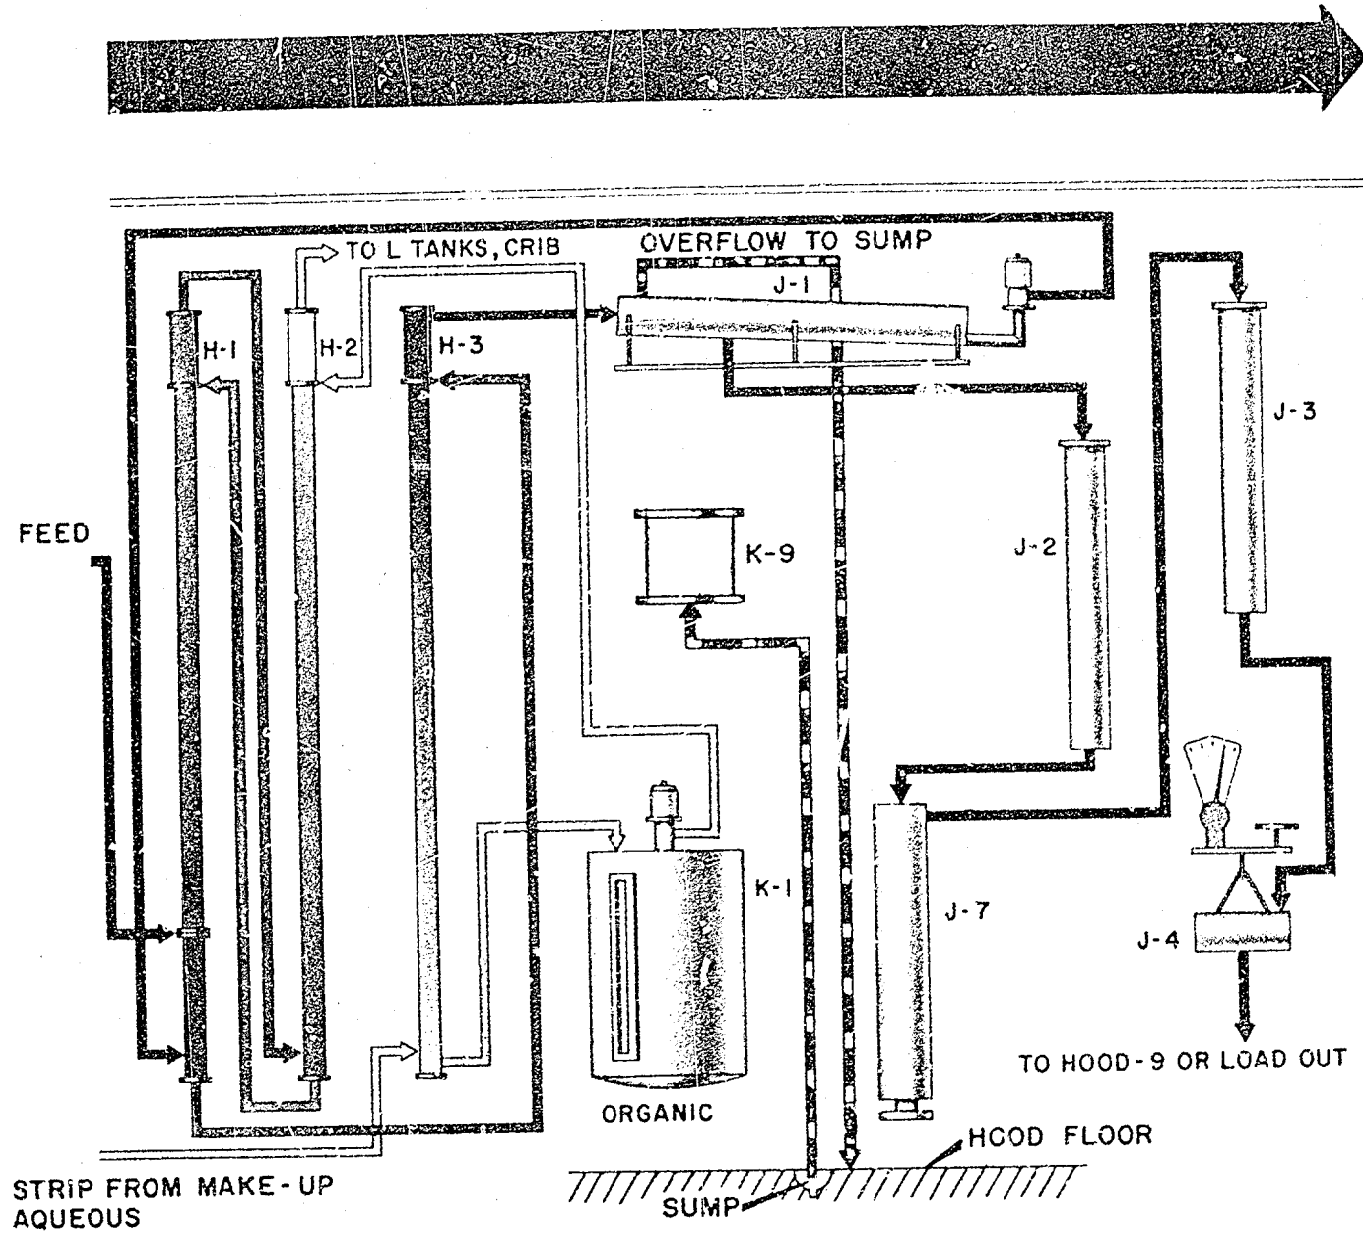
FIGURE 3
Pictorial Flow Diagram of SE Process

Fig. 3 is a pictorial flow diagram of the SE process. This figure concerns itself mainly with the route by which product solution entered the K-9 tank, viz., from the J-1 tank via the J-1 overflow to the sump, and from the sump via the one inch temporary plastic tube to the K-9 tank.

1. During the latter part of the 12-8 shift on April 7, product solution flowed intermittently from the top of column H-3 (solvent extraction stripping column - see Fig. 3 for flow diagram) to vessel J-1 (a product receiver tank) and was intermittently removed from J-1 during this period. However, during part of the period, input sufficiently exceeded output to cause J-1 to fill and then to overflow. The overflow went via a line provided for the purpose to the floor of the SE hood.
2. At some time within several minutes before 10:59 a.m., and while suction was on tank K-9, valve #944 was opened, allowed to remain open for a few minutes, and then closed. This resulted in sucking some of the strong product solution from the sump (where it was in a thin slab geometry and therefore, necessarily subcritical) into K-9 where its geometry became such as to make it almost critical.

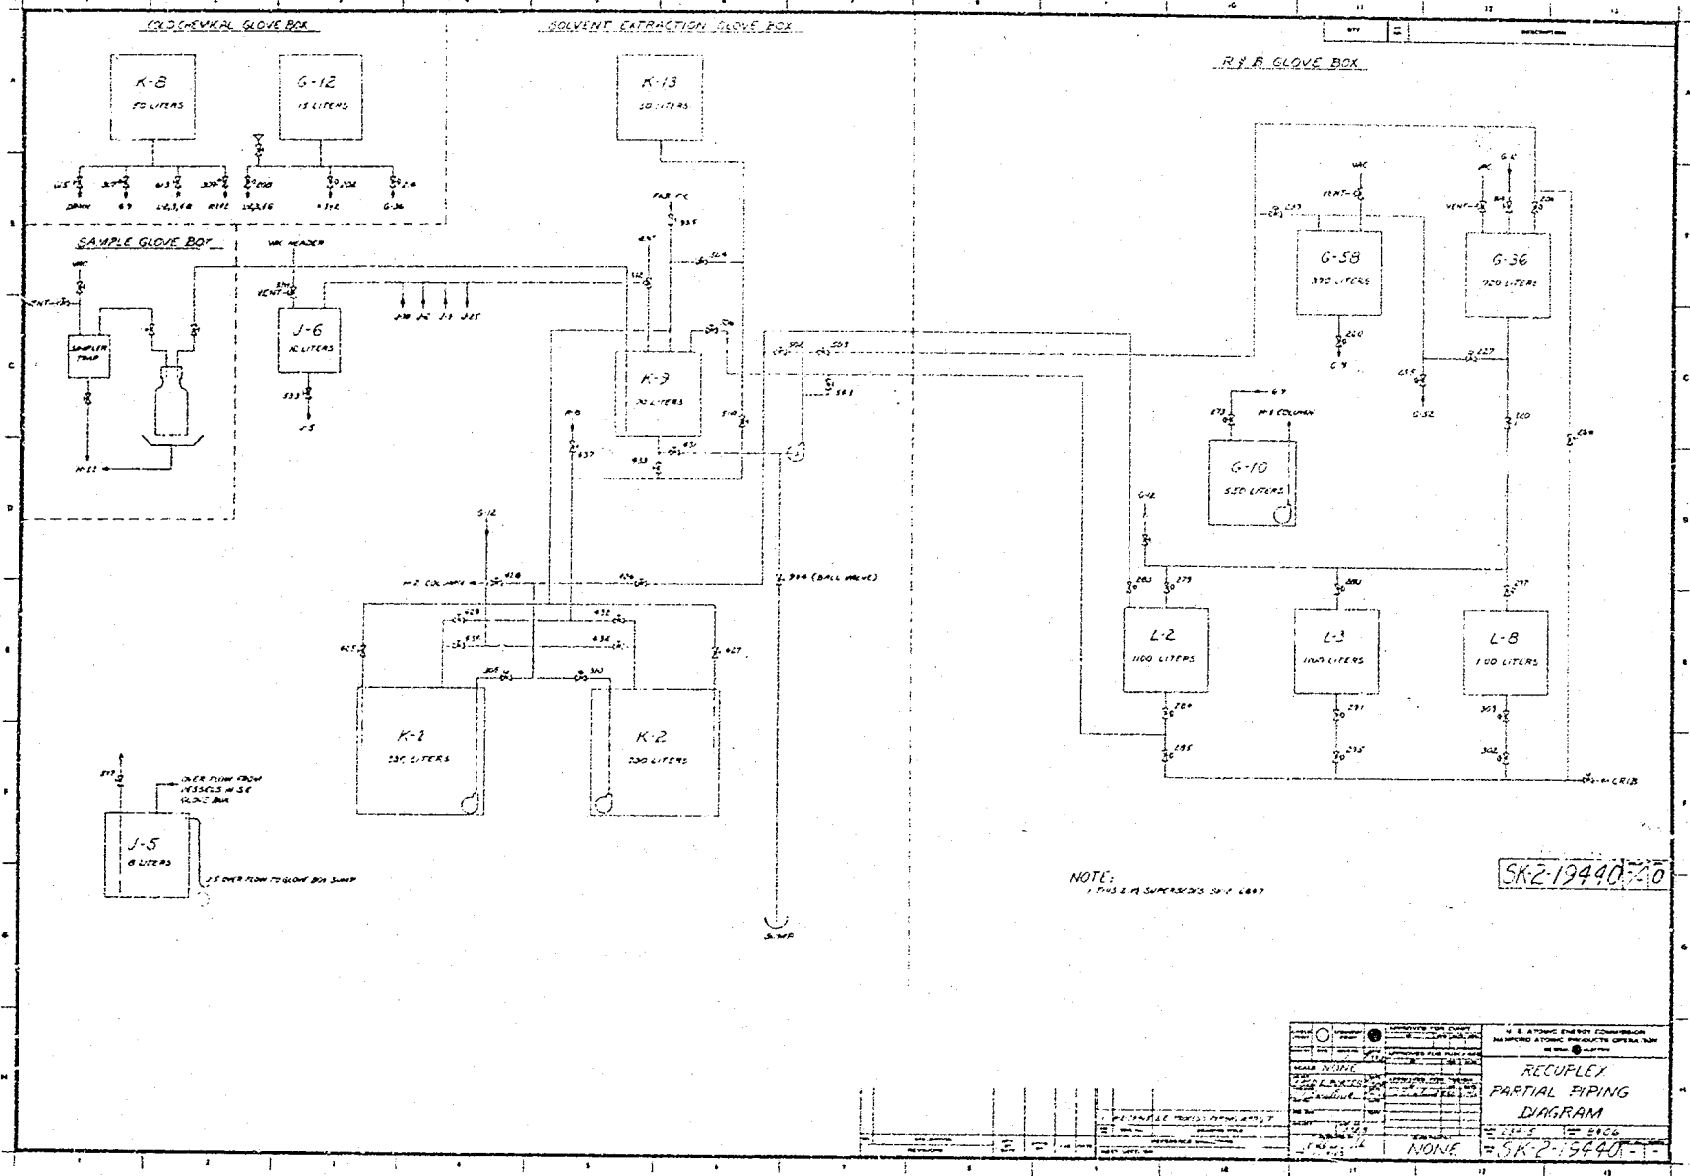
FIGURE 4

Approximately 130 liters were moved from L-2 back to G-36 and 200 liters were to be drawn in four batches from L-2 to K-9 tank by vacuum and dropped by gravity to the K-2 tank for washing with an aqueous phase containing ferrous sulfamate and hydrofluoric acid to extract the plutonium. This aqueous phase, after sufficient contact time, was to be decanted into the K-9 tank and then pumped to the G-58 tank for later use (see Fig. 4)

3. The 8-4 shift continued the transfer of contact organic from L-2 thru K-9 to K-2 by opening valve 506 (shown on Fig. 4) which is the normal route from L-2 to K-9. The 543 and 431 valves opened and used for transfers by the operator on the previous shift, and reportedly left open by him, apparently were not closed by employee No. 1, the employee who conducted these transfers. This allowed material to be moved into K-9 from L-2 by two routes simultaneously. This transfer continued intermittently during the morning of April 7, 1962, until a total of 3 or 4 batches of approximately 50-55 liters each had been transferred into K-2 tank. (Operator recollection is hazy as to whether 3 or 4 batches were transferred). The intermittent operation occurred due to interruptions caused by a flooding condition in the solvent extraction columns which required the operator's attention.
