SUMMARY REPORT

ACCIDENTAL NUCLEAR EXCURSION

RECUPLEX OPERATION

234-5 FACILITY

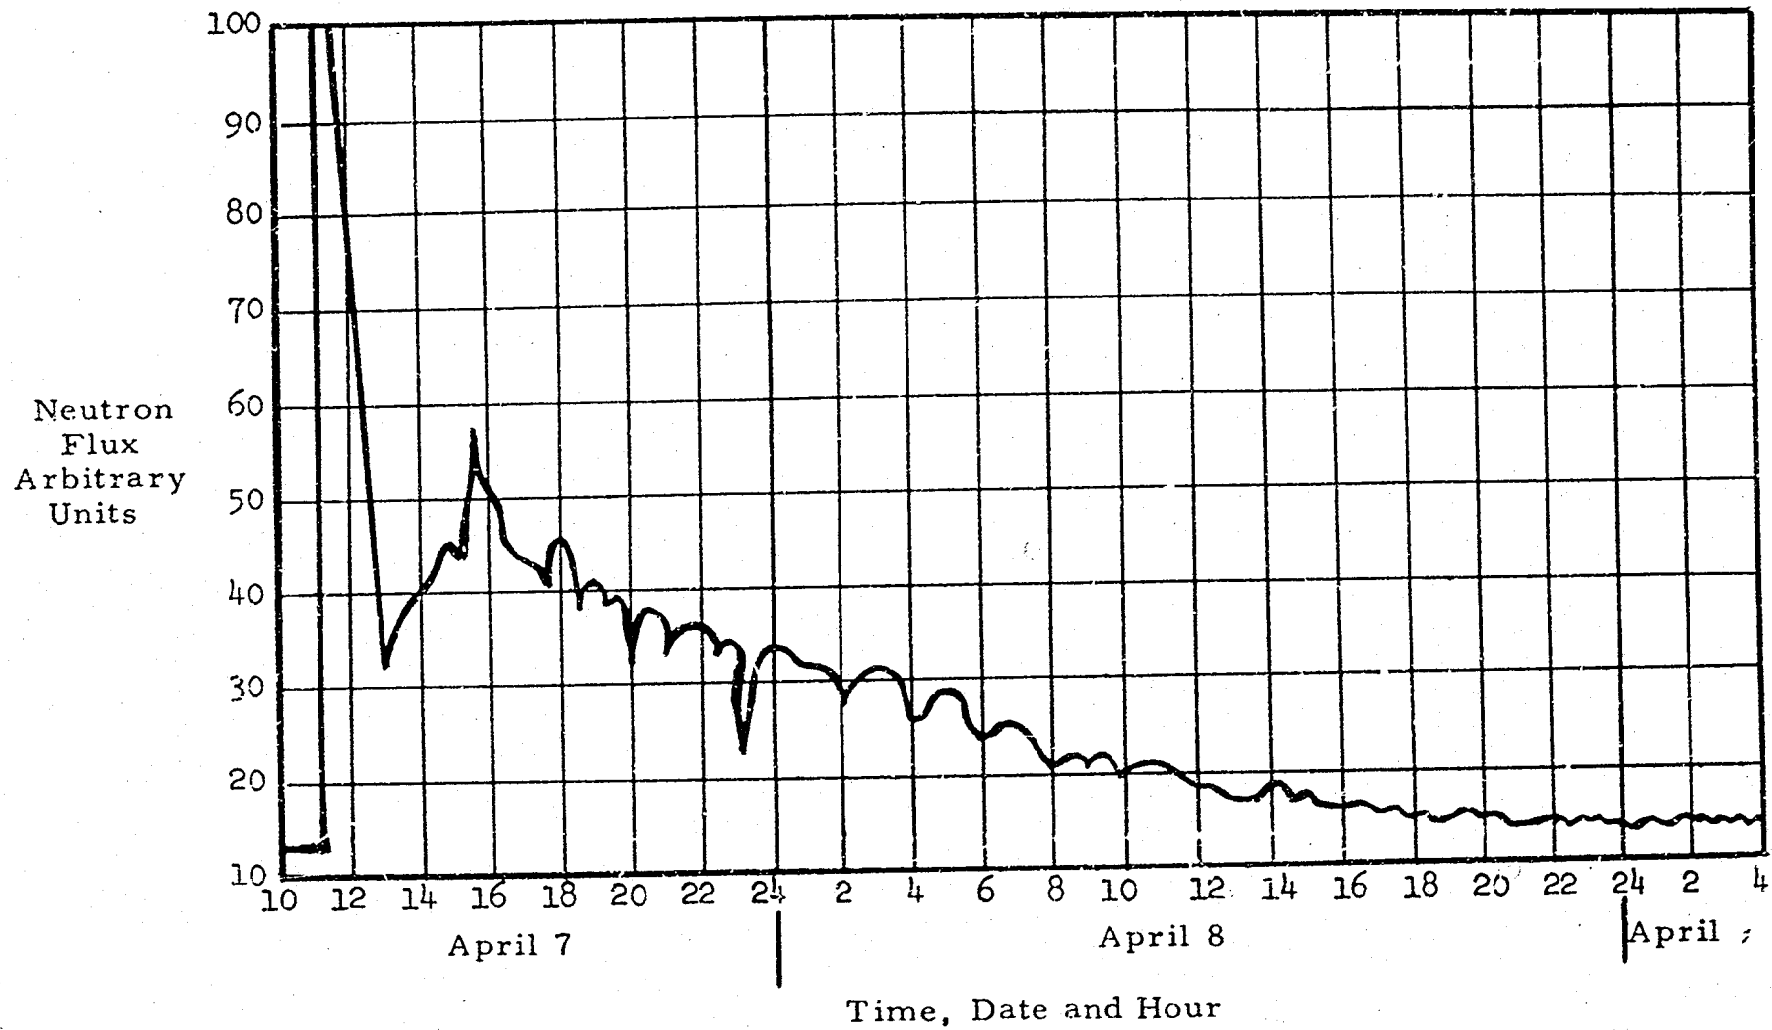
FIGURE 5
Measured Neutron Flux at Point Outside 234-5

that after the first two or three hours (before fully systematic observations had started) the chain reaction rate had been decreasing. For this reason, although a number of proposals for stopping the reaction had been made and seriously considered, it was concluded that the best course of action consisted of allowing the reaction to die by itself if it would do so, as seemed likely. Fig. 5 shows the measured neutron counting rates at a point about 110 feet from the K-9 tank, and somewhat shielded from it by concrete walls. As shown on the chart, the neutron flux dropped to background about 37 hours after the accident. Gamma measurements taken during this period are in agreement with the cessation of the chain reaction at about midnight, April 8.

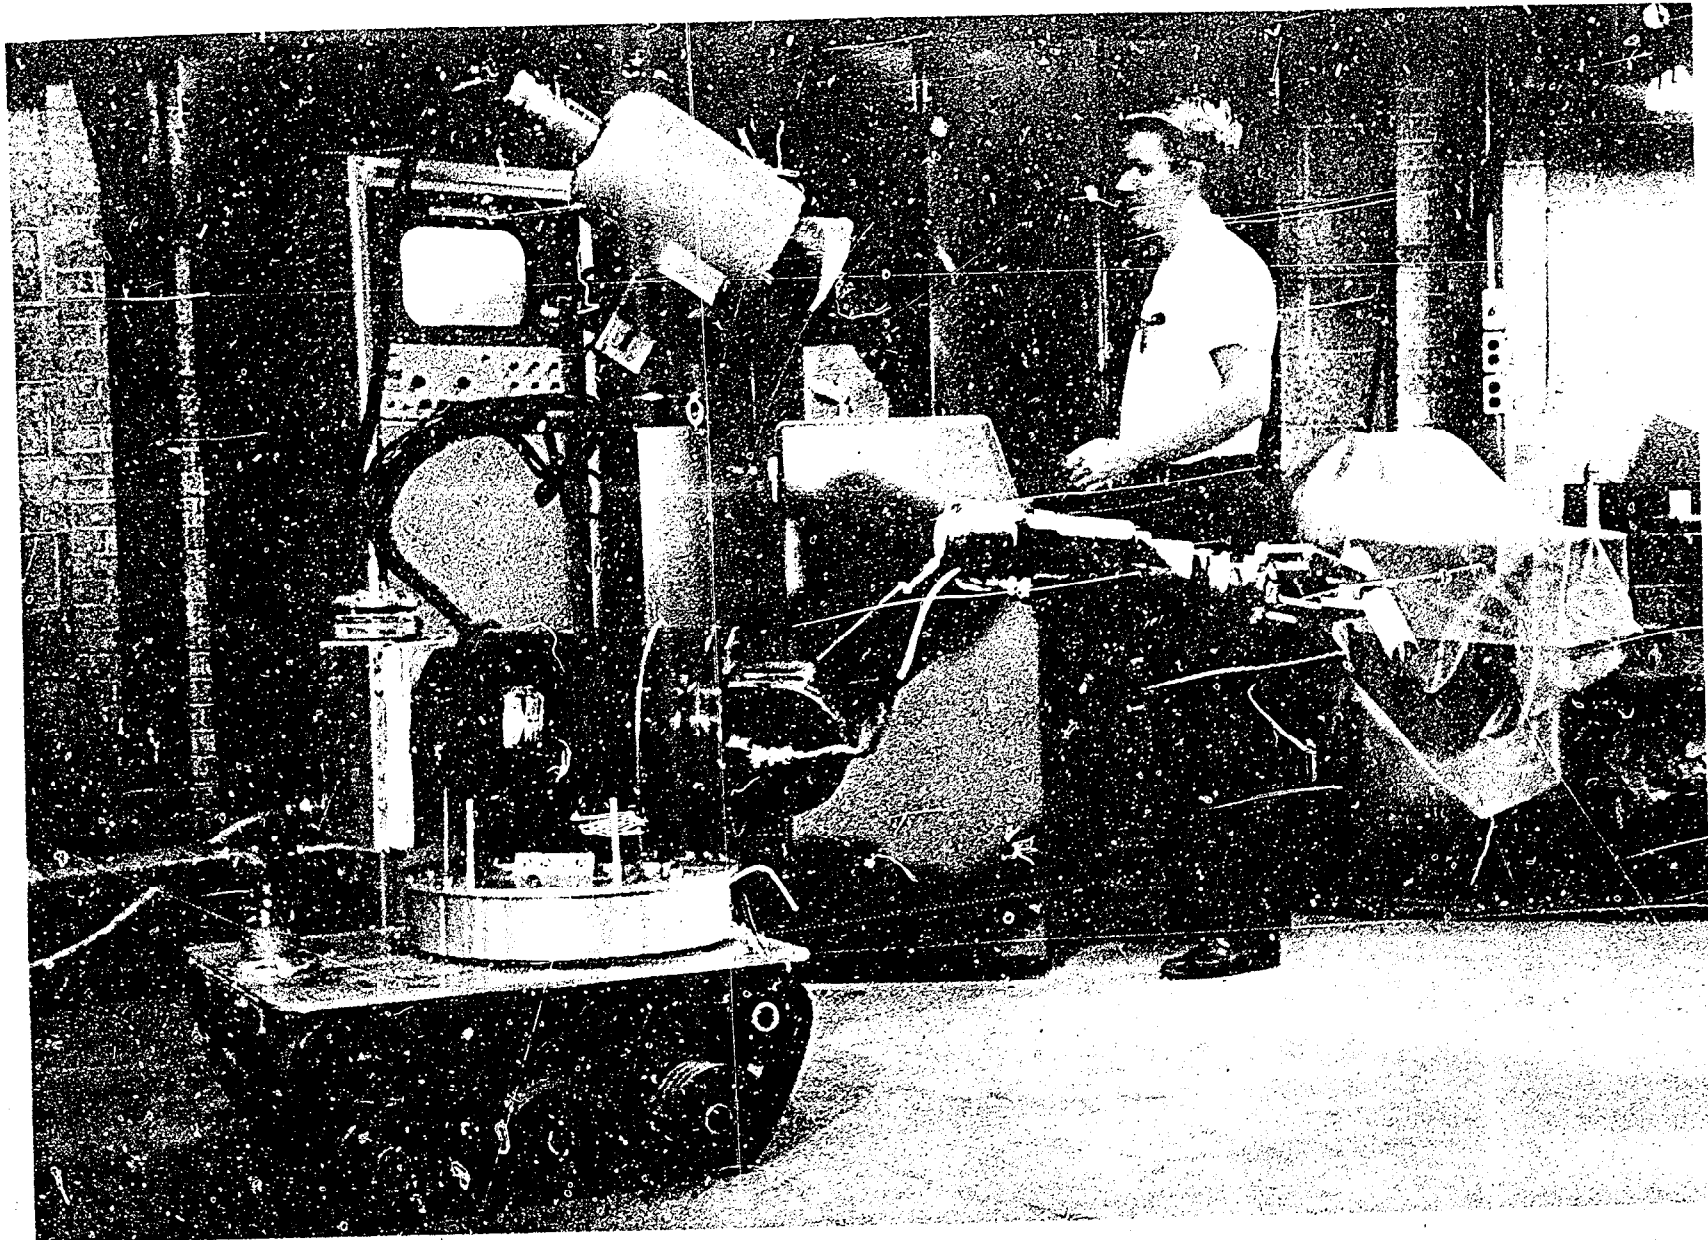
FIGURE 6
Remotely Controlled Robot, TV Camera and Console

It was determined that the first step would be entry by a small remotely-controlled robot which had been constructed for use in the event of a reactor accident requiring the remote handling of irradiated fuel slugs (Fig. 6). This device was rigged up to carry a television camera and other equipment. The TV camera enabled the remotely-situated operator to steer the robot clear of obstructions, and also to perform a variety
